**Report of Investigation into  
the Sinking of Hong Kong  
Registered General Cargo / Log  
Carrier *New Lucky VII* at Sea  
West of Amami Oshima, Japan  
on 03 April 2012**

The Hong Kong Special Administrative Region  
Marine Department  
Marine Accident Investigation Section

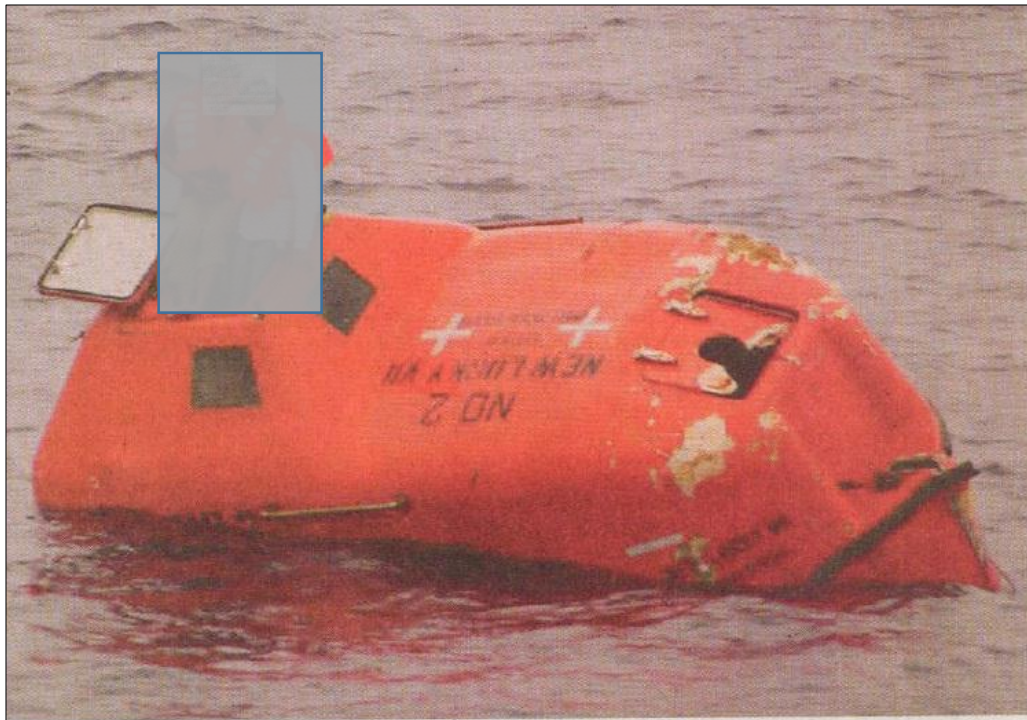
- 4.16 The second officer clung to a piece of log floating on the sea. He saw an inflated liferaft which probably was the one with the nine crewmembers on board at a distance away from him. Thinking that it was impossible for him to swim to that liferaft, he gave up. Then, he saw No.2 lifeboat which was from the port side of the vessel drifting behind him. The second officer managed to board the lifeboat which had been partially damaged at forward and aft as well as to her canopy. Later, the second officer helped the cook who was holding a lifebuoy floating nearby to board the lifeboat (Fig. 3).

Fig. 3. – No.2 lifeboat (partly damaged) with two survivors on board drifting at sea

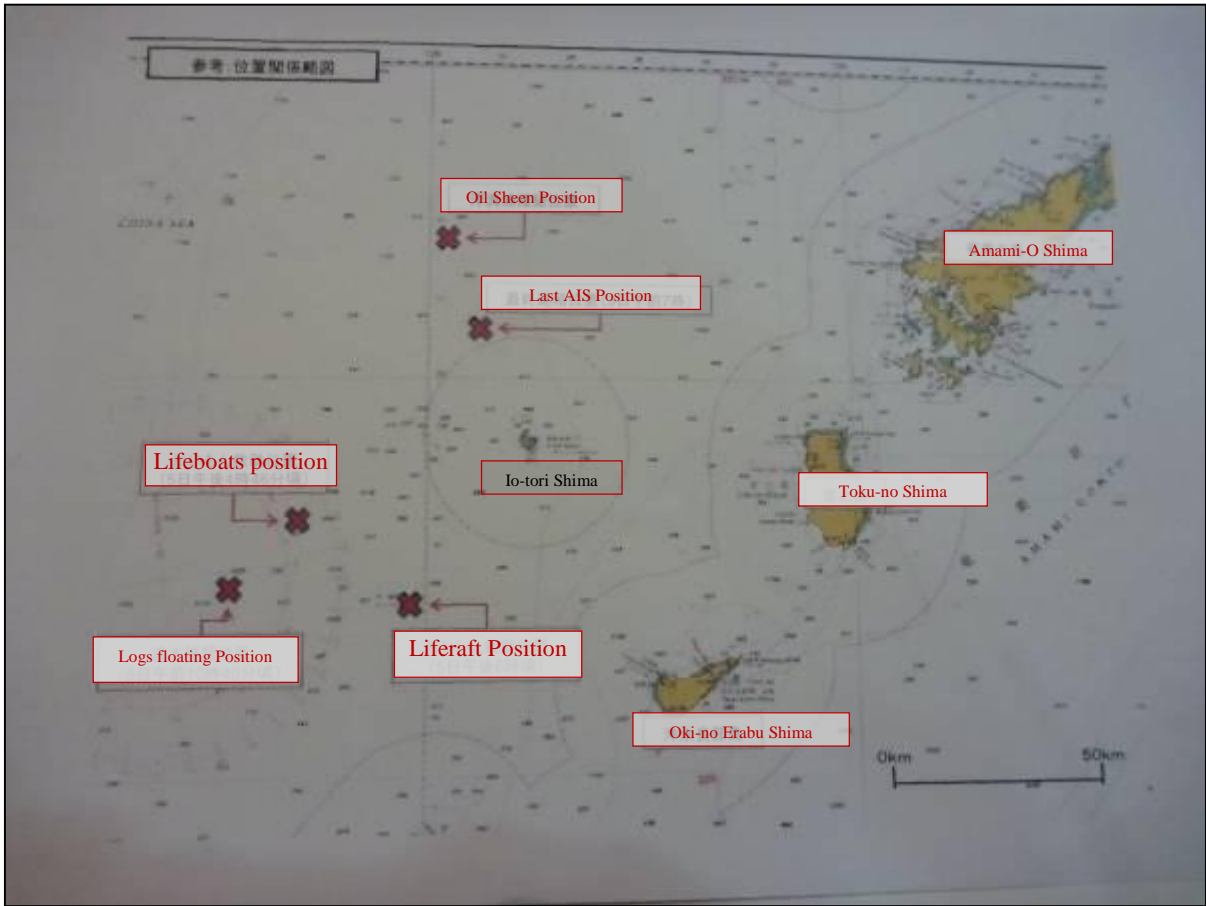
- 4.21 At 1330 on 5 April 2012, the Japanese Coast Guard's helicopter and ships launched the SAR operation. At about 1700 on the same day, a lifeboat without crew on board (No.1 lifeboat) and a lifeboat with two crew members on board (No.2 lifeboat) in approximate position 27°41.39'N, 127°43.09'E were located (Fig.4). Also about one hour later, the liferaft with a total of nine crewmember inside was found at position 27°31.9'N 127°57.2'E. Oil sheen was found in position 28°17.6'N, 128°03.8'E. Eventually the 11 crew members were rescued about 58 hours after the accident. The rest of the six crewmembers of the vessel could not be found and the SAR operation stood down on 11 April 2012.

Fig. 4 – The positions of findings in the SAR operation on 5 April 2012

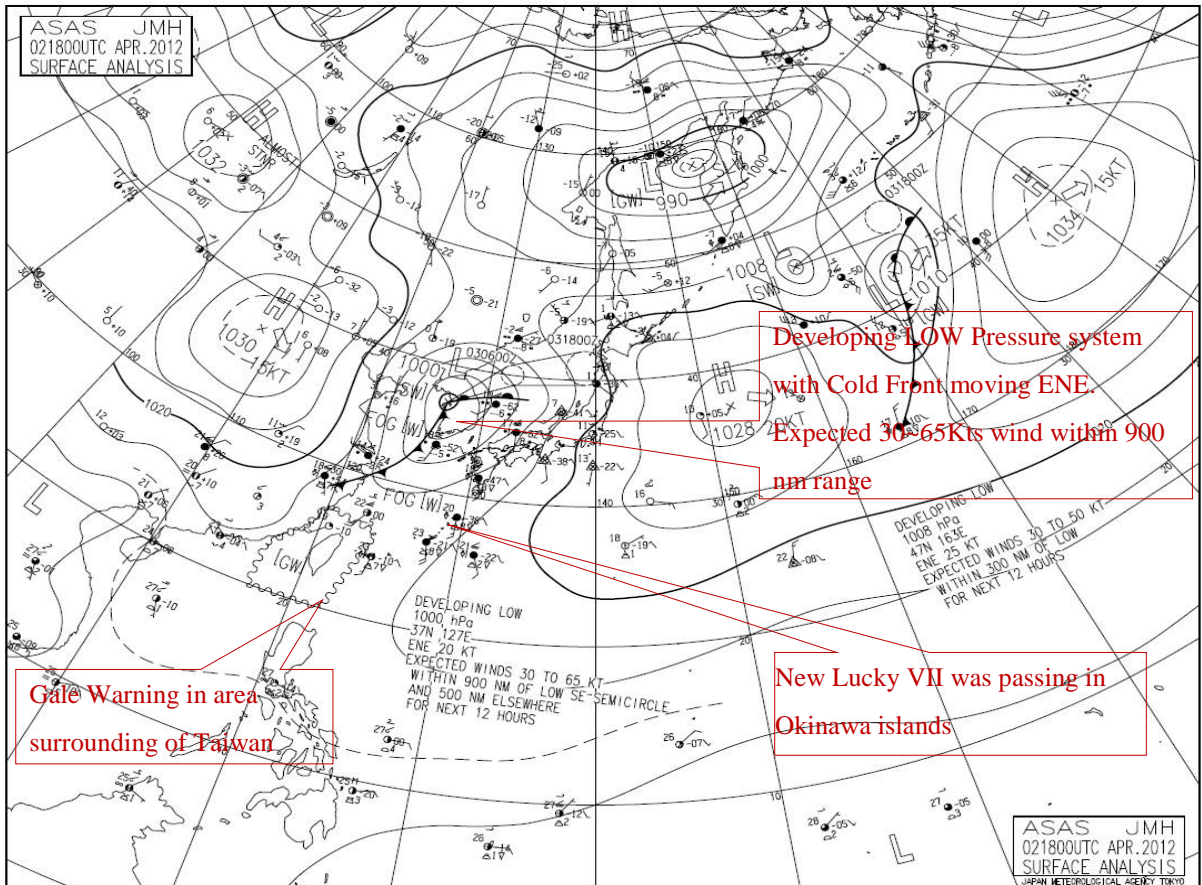
- 5.16. According to the Surface Analysis Charts provided by the Japan Meteorological and Hydrological Services (JMH), at 0300 3 April 2012, a low pressure system of about 986 hp<sup>2</sup> was at a distance about 600 nautical miles north of the position of the accident with the existence of an easterly cold front. The weather warning showed that strong winds in the range from 30 to 60 knots was expected within 900 miles in southeast-semicircle and 500 nautical miles in other area. Also, another gale warning patch was located in the strait of Taiwan. Therefore the rough sea condition, compounded with long swell caused by the strong wind, could be encountered by *New Lucky VII* in the sea area west of Amami Oshima. (Fig.6 & 7).

Fig. 6 – Surface analysis at 0300 (UTC+9) of 3 April 2012

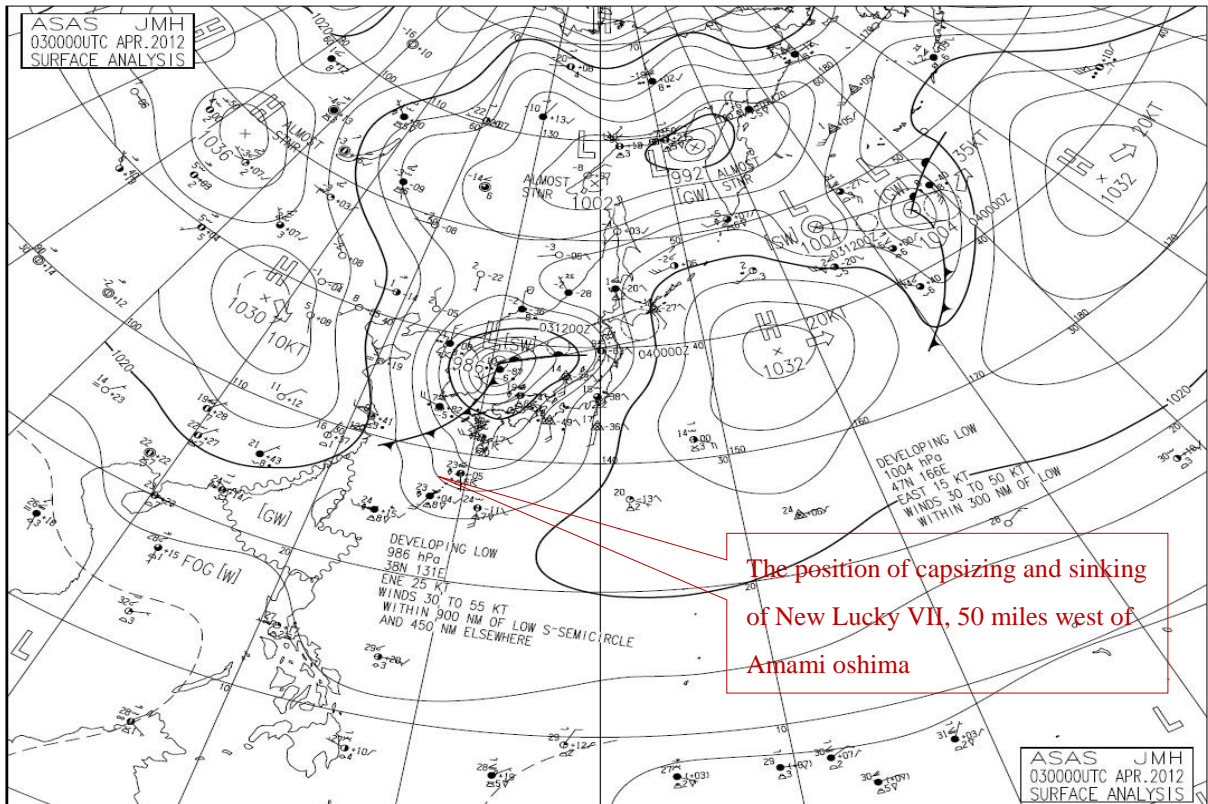
Fig.7 – The Surface Analysis at 0900 (UTC + 9) of 3 April 2012.

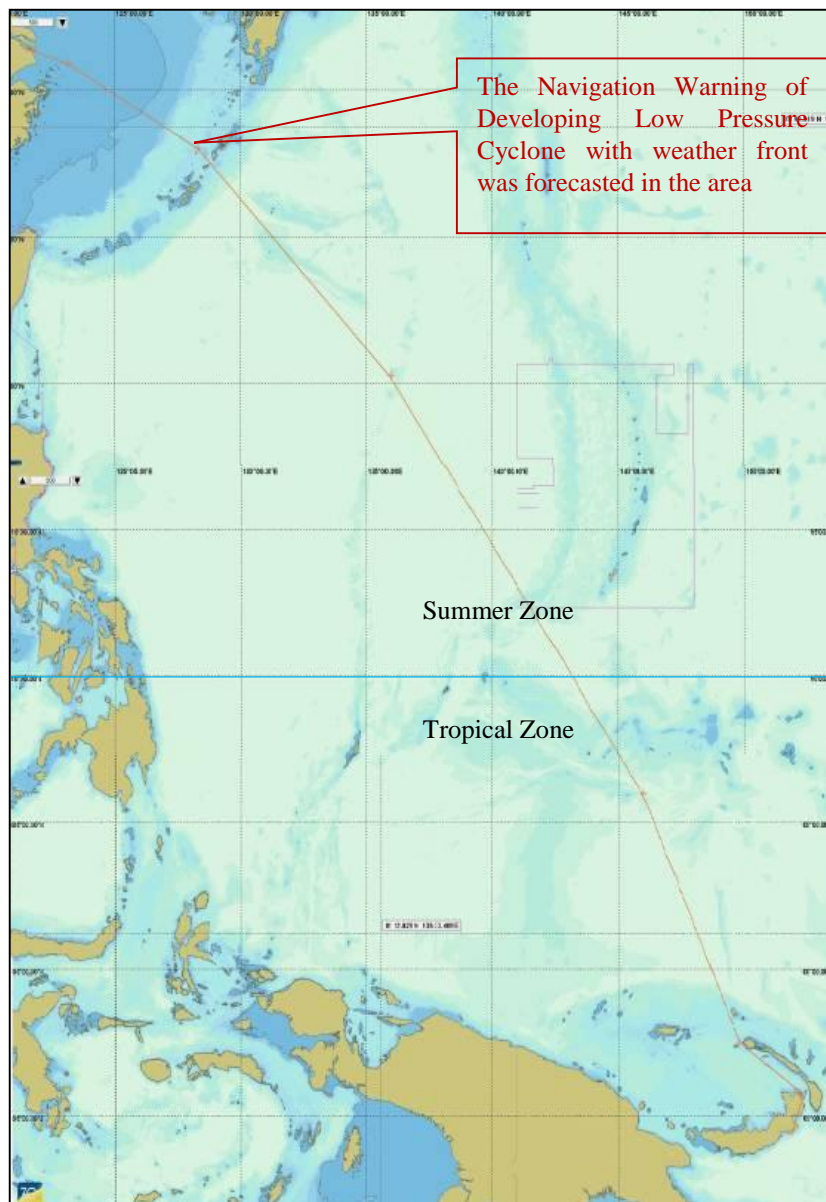
- 5.21. Before departure, the master instructed the second officer to prepare two voyage plans from Rabaul, Papua New Guinea to Chang Jiang Kou, China for his consideration. The second officer prepared two passage plans listing out the waypoints. One route was to pass through Guam, Islands of Okinawa and Amami Oshima; and the other through north of Papua New Guinea, east of the Philippine and east of Taiwan. The former route was about two days shorter and was adopted by the master.

Fig. 9 - The voyage plan via Guam and Amami-Oshima

- 5.22. However, the master of the vessel did not consider the possibility of adverse weather and sea condition usually occurring in East China Sea during the first half of the year of monsoon wind season. There was no contingency plan

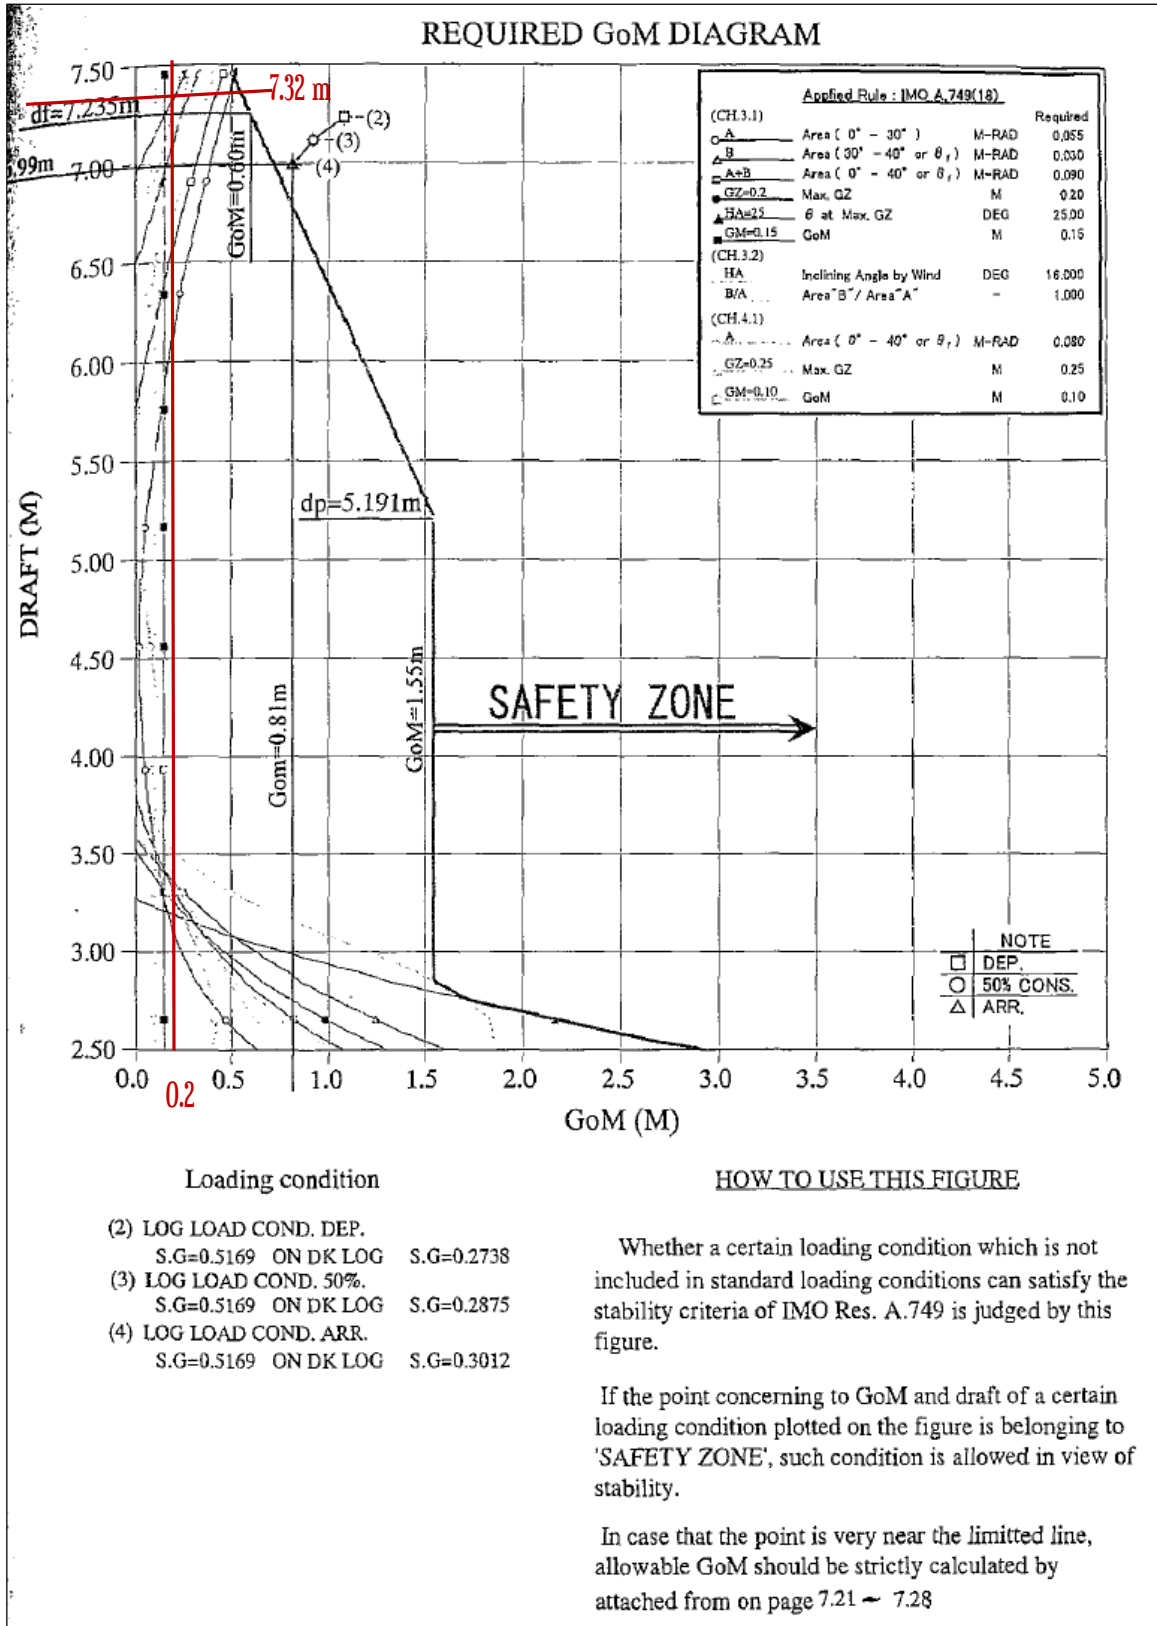
**Appendix 2 - Plotting the GoM 0.20 m & Draft 7.325 m into the Required GoM Diagram**

- 5.10. The principle particulars of the vessel are provided in Appendix 1.
- 5.11. Before vessel departed from the loading port (Tropical Zone) on 24 March 2012, the GoM and mean draft of the vessel reported by the master were respectively 0.20 m and 7.32 m. Based on these information and using it to plot on the GoM Diagram (Timber Deck Cargo) provided in the ship stability booklet, it was apparent that the ship's intact stability was inadequate (i.e. it fell outside the Safety Zone of the GoM Diagram), implying that she was not stable upon departure (refer Appendix 2).

**Conclusion:** By plotting GoM of 0.20 m (provided by the master) and mean draft of 7.32 m (departure draft) on the Required GoM Diagram (Timber Deck Cargo), it indicated that the intact stability was outside of the Safety Zone.

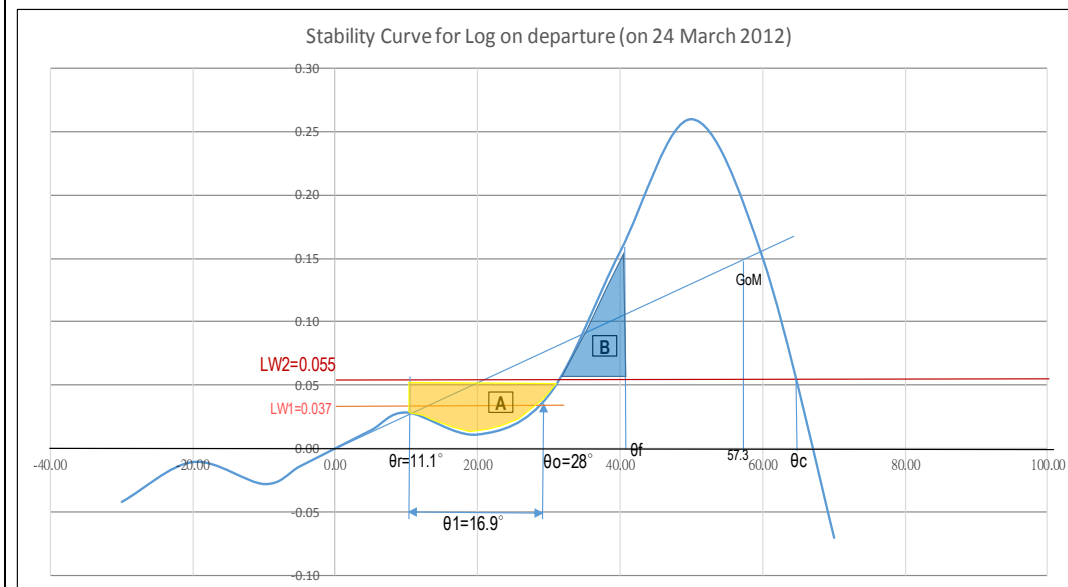
.10 The stability curve under the above conditions was generated. It revealed that the vessel only met the stability criteria regarding GoM (0.15 m cf 0.1 m), not the criteria of area under curve (0.03 m.rad. cf 0.08 m.rad.) and the maximum righting lever (GZ) were respectively (0.17 m cf 0.25 m).

| Applied Rule IMO A.749(18), Chapter 4.1 Stability (log) | | | | | |
|---|---|---|---|---|---|
| Area (0 to 40° or $\theta_f$ ) | M-rad | 0.08 | > | 0.03 | Fail |
| Max. GZ | M | 0.25 | > | 0.17 | Fail at 40.25° |

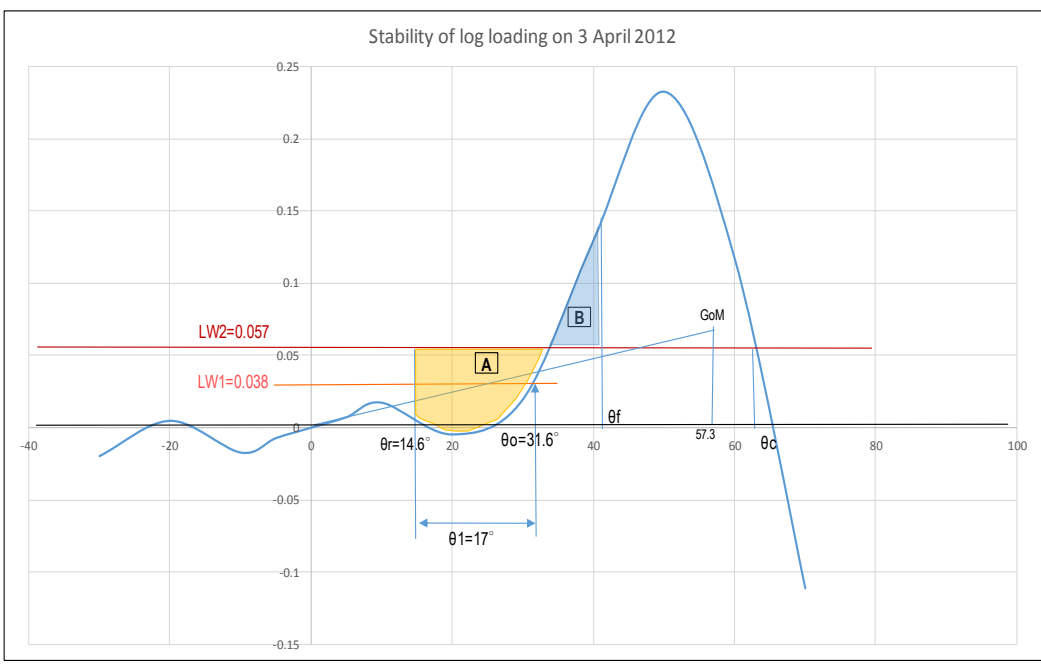
| Applied Rule IMO A.749(18), Chapter 4.1 Stability (log) | | | | | |
|---|---|---|---|---|---|
| Area (0 to 40° or $\theta_f$ ) | M-rad | 0.08 | > | 0.02 | Fail |
| Max. GZ | M | 0.25 | > | 0.14 | Fail at 41.22° |

Conclusion: On the passage to China on 3 April 2012, the stability of *New Lucky VII* could not meet the stability requirements of IMO Res.A.749 (18). Furthermore, according to statements provided by the crew, the gusting wind force at the time of the accident was more than 60 knots (wind load about 880N/m<sup>2</sup>), the wind load on windage area was more than 504N/ m<sup>2</sup> (the assumed wind load in the calculation), and the waves were boisterous. The weather condition was severer. The assessment did not consider
