**Report of Investigation into  
the Sinking of Hong Kong  
Registered General Cargo / Log  
Carrier *New Lucky VII* at Sea  
West of Amami Oshima, Japan  
on 03 April 2012**

The Hong Kong Special Administrative Region  
Marine Department  
Marine Accident Investigation Section

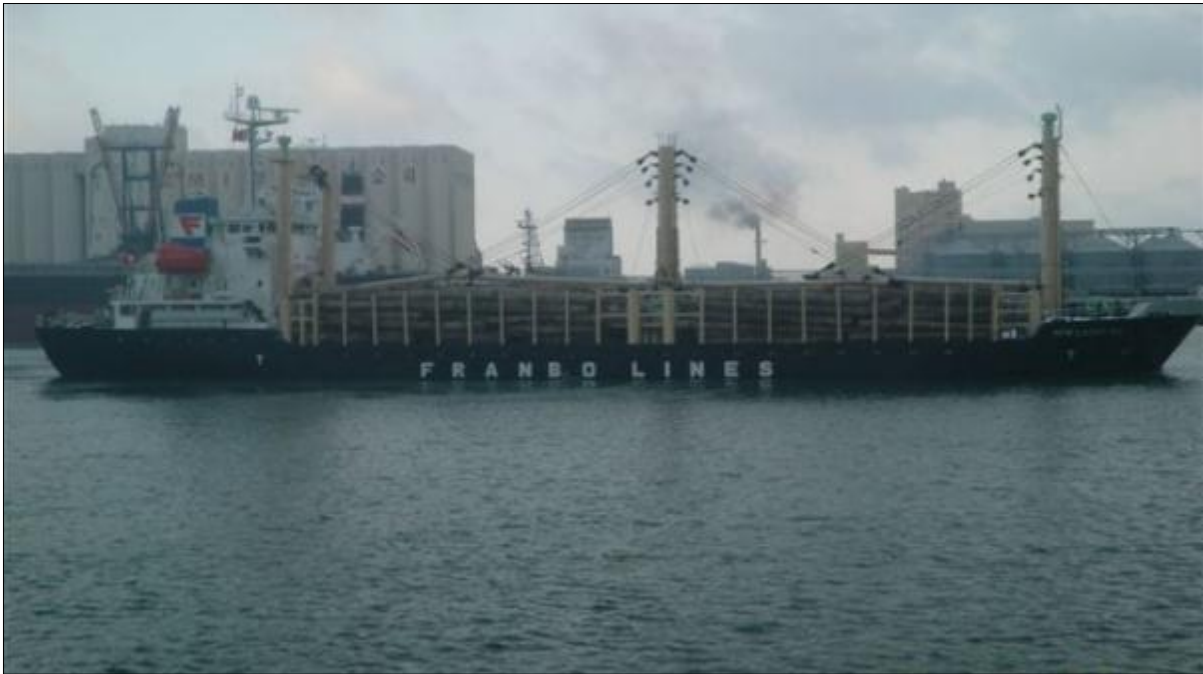
Fig. 2 – Photo shows *New Lucky VII* fully laden with logs

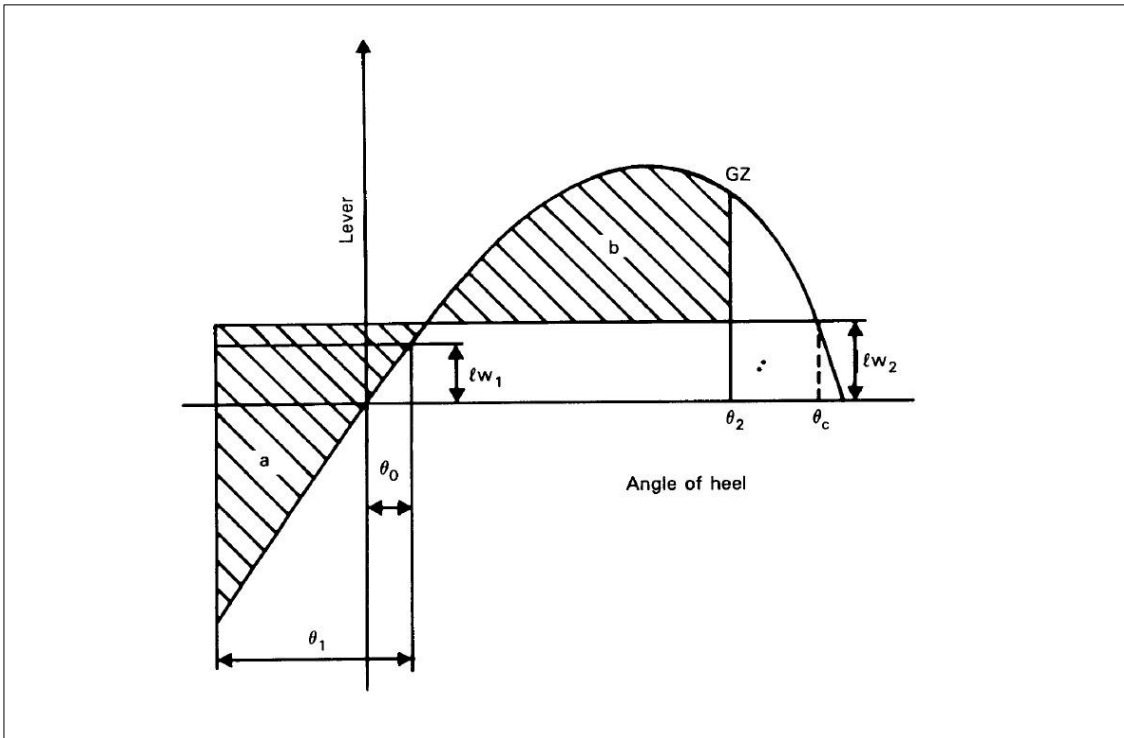
- 5.9. Paragraph 3.2 of *the Code* stipulates severe wind and rolling criterion (weather criterion). The ability of a ship to withstand the combined effects of beam wind and rolling should be demonstrated for each standard condition of loading. According to *the Code*, when a ship is subjected to a steady wind pressure acting perpendicular to its centre-line, a steady wind heeling lever will result. The angle of heel under action of steady wind should be limited to a certain angle to the satisfaction of the Administration. As a guide,  $16^\circ$  or 80% of the angle of deck edge immersion, whichever is less, is suggested. When the ship is then subjected to a gust wind pressure which results in a gust wind heeling lever, area "b" should be equal to or greater than area "a" under these circumstances (Fig. 5).

Fig.5 – Sever wind and rolling stability criteria.

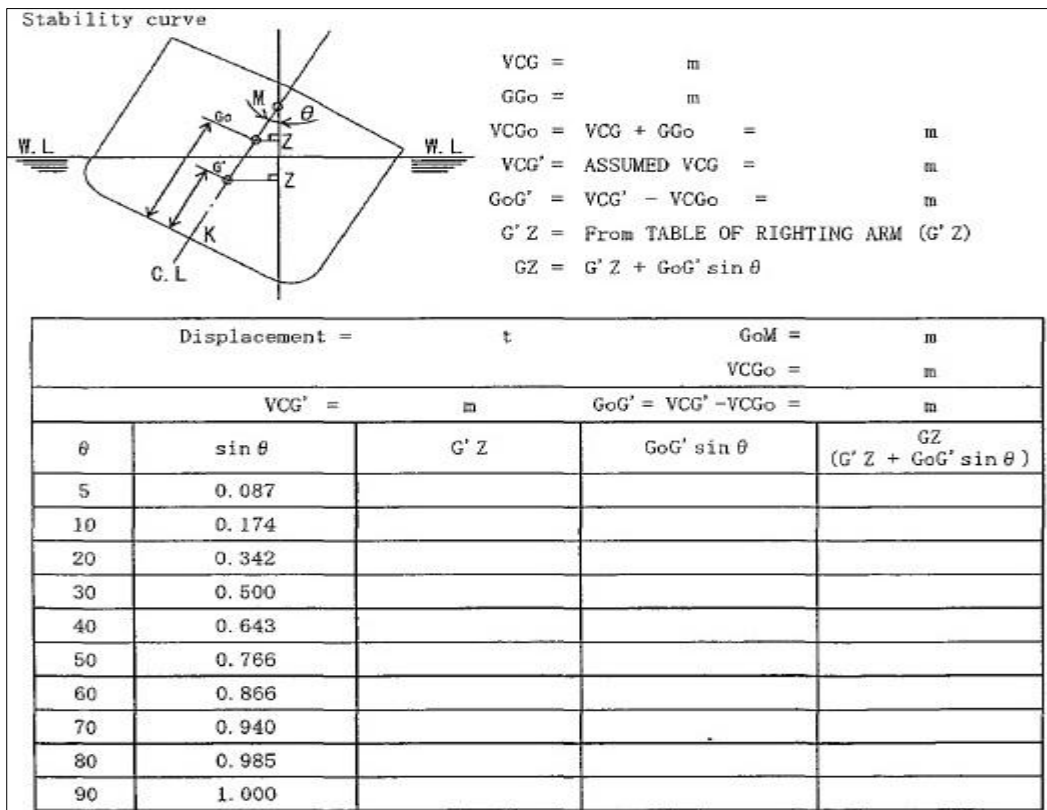
Stability Curve for timber deck cargo (IMO A. 749(18) 4.1)

.10 The stability curve under the above conditions was generated. It revealed that the vessel only met the stability criteria regarding GoM (0.15 m cf 0.1 m), not the criteria of area under curve (0.03 m.rad. cf 0.08 m.rad.) and the maximum righting lever (GZ) were respectively (0.17 m cf 0.25 m).

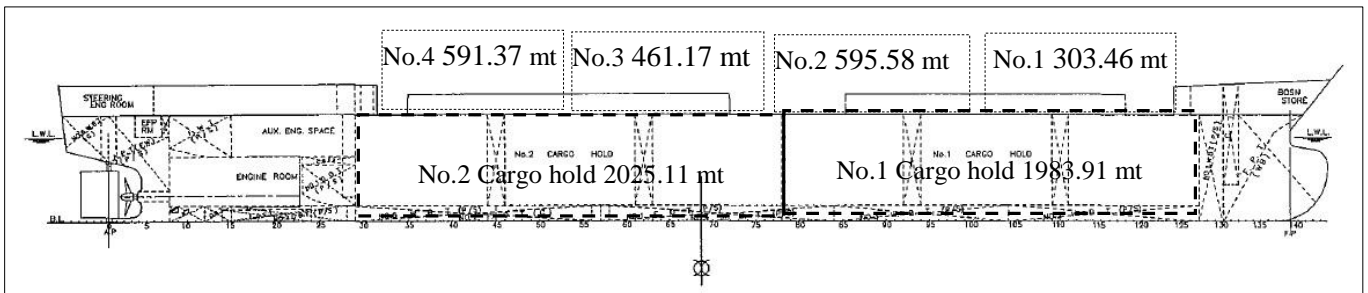
Cargo weight distribution on departure as following table:
